Manhole Inspection Summary

Manhole # S69Q__012MH

Location Address: **1412 Dunalk Ave.**

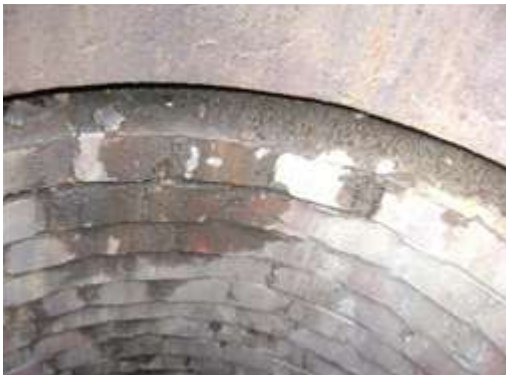
Defect 1

Infiltration: ☐ None ☒ **Joint** ☐ Cracks ☒ **Mortar** ☐ Roots ☐ Wall

infiltration at frame

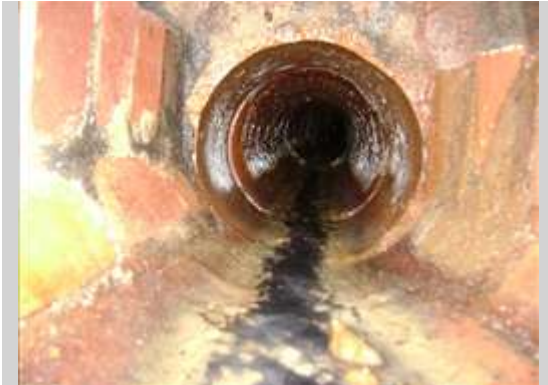
12 O'Clock Outflow

Deposits: ☐ None ☐ Mud ☐ Sludge ☐ Debris ☒ Grease

Silt Depth: **0.125** (in.) Deposits Extent: **Light**

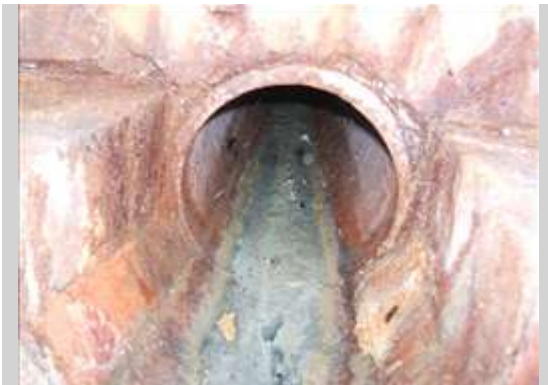
3 O'Clock Inflow

Deposits: ☐ None ☐ Mud ☐ Sludge ☐ Debris ☒ Grease

Silt Depth: **0.125** (in.) Deposits Extent: **Light**
